# **BENTONITE - LINING BARRIER Around a former landfill in Maassluis**

April 1994

Authors:Henk ClooDHVHans van EijkCofraAlbert BresserFundamentum

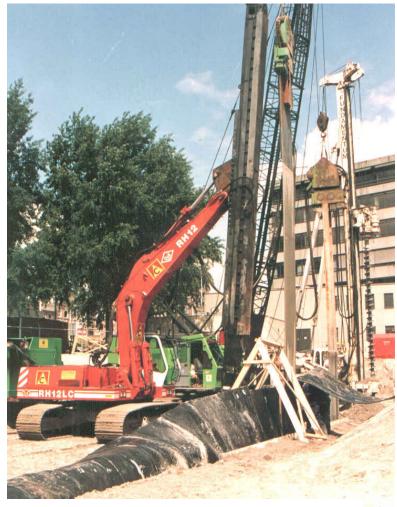
Figure 4 Drilling, bentonite trenching and Geolock installation rig on a row Rig

Because of the presence of rubble and broken concrete in the landfill, it was necessary to prebored pilot holes under a bentonite / cement slurry. The bentonite suspension was prepared in a hydration tank then pumped to the mixer in which the required amount of cement was added. The bentonite/cement mixture was then held in a storage vessel until it was pumped to the point of installation. The level of the bentonite/cement slurry was constantly monitored to ensure that it remained flush with the ground surface. After approximately 2 linear meters of wall was opened, the Geolock panels were immediately installed so as to prevent any damage by the rubble.

The actual installation of the 2 m wide Geolock panels was accomplished using a steel framework especially designed for this purpose. The framework was lowered between 2 ground-mounted guide beams that insured positive control of the installation. An indicator system used during installation of the Geolock panels guarantees that all interlocks are fully connected.

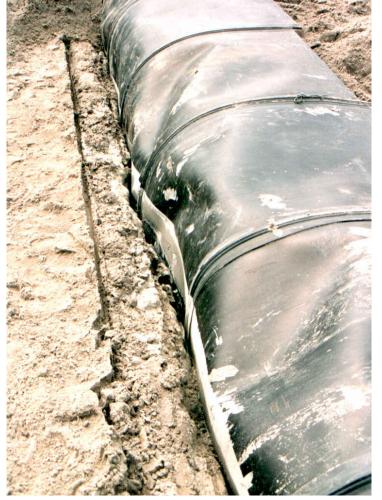
Figure 5 Installed Geolock panels
